**ASBESTOS BUILDING INSPECTION
REPORT**

**Former Carrier-Bryant Manufacturing Corporation
Facility Buildings
1100 West 21st Street & 1139 West 23rd Street
Indianapolis, Indiana 46208**

January 03, 2011

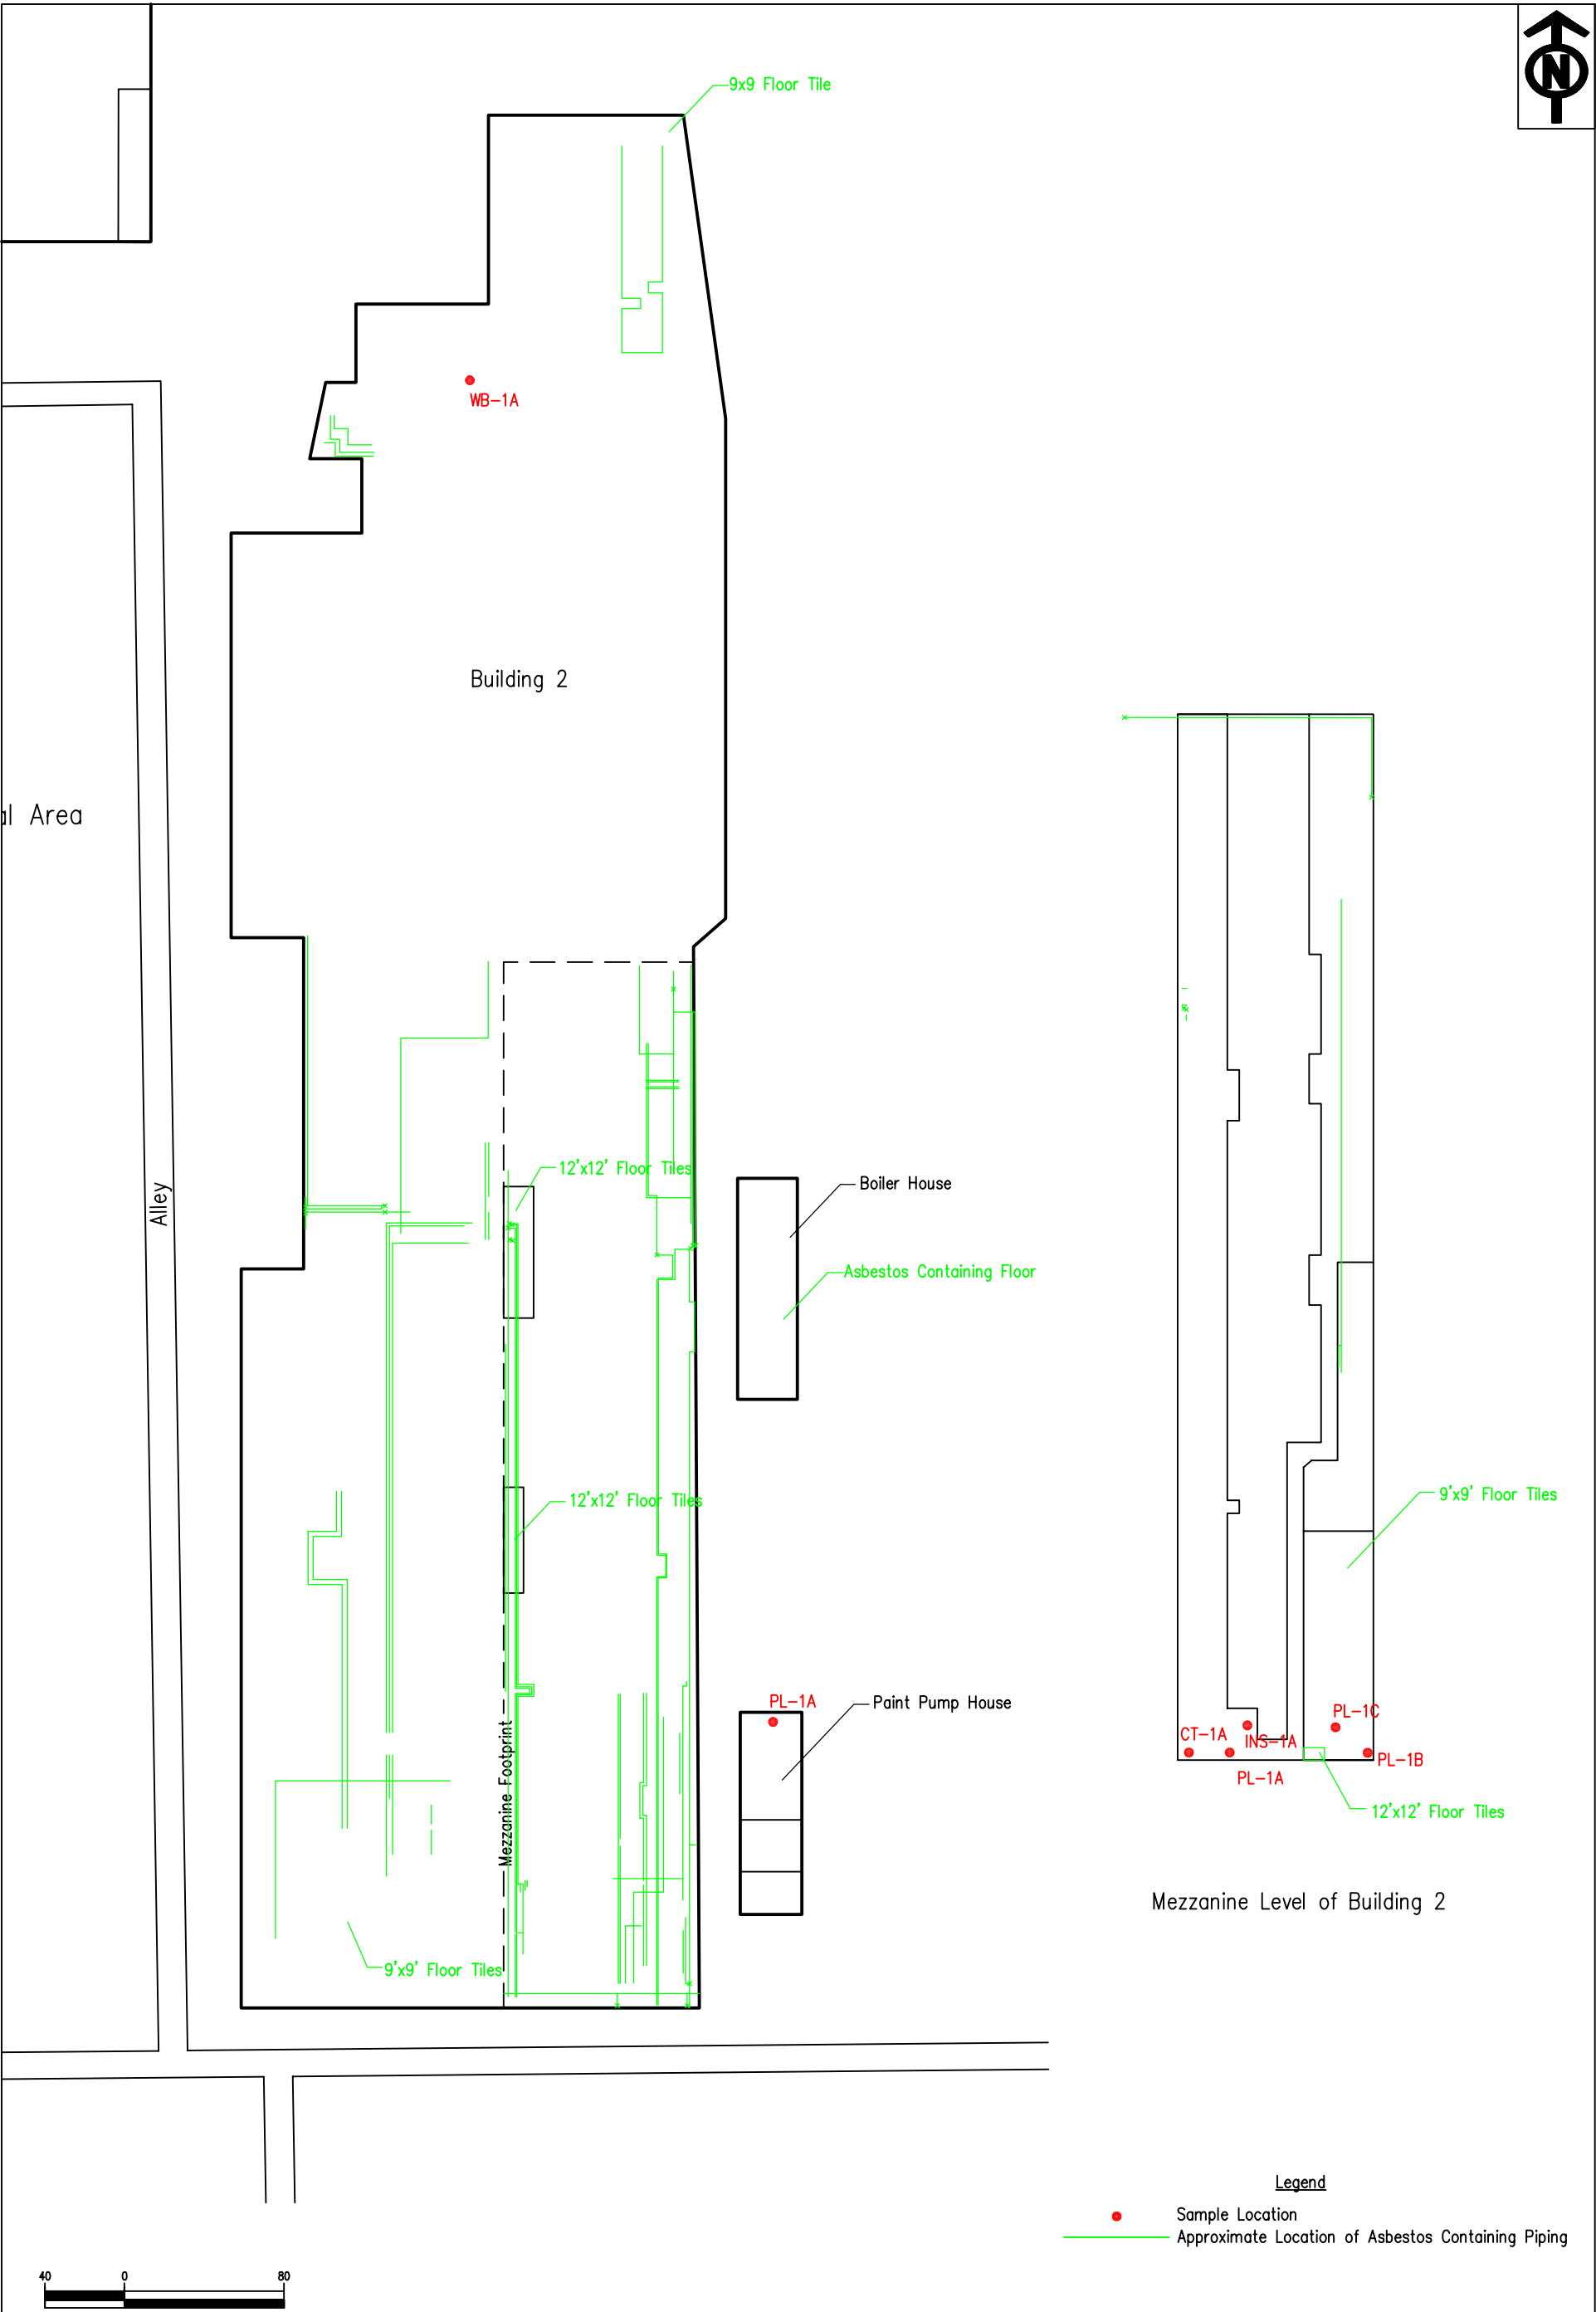
Heartland personnel obtained 22 bulk samples from 16 homogeneous areas of suspect materials for laboratory analysis. These sampled materials consisted of 2 types of ceiling tile, 1 type of cove base material with associated mastic, 1 type of drywall material, 1 type of insulation material, 3 types of resilient vinyl flooring material with associated mastic, 4 types of asphalt roofing material, 1 type of cement piping material, 2 types of plaster material and 1 type of wallboard material. Site layout maps depicting sample locations are provided as Figure 3 and Figure 4.

The TSI was located on vertical and horizontal pipe runs throughout the first floor and mezzanine levels in Building 2 and within the Boiler House building. Some of the TSI pipe run was identified amidst sections of fiberglass pipe insulation. In several areas, piping had been replaced with newer fiberglass insulation. TSI pipe run was easily identifiable amidst this newer pipe insulation. Numerous pipe connections were also identified with mudded asbestos joints throughout these sections.

Cement piping material was identified in piping debris and vertical and horizontal pipe runs in Building 5. Approximately 1,500 square feet of ceiling and wall plaster was located in the southern portion of the mezzanine level of Building 2. Additionally, approximately 420 square feet of transite wallboard was observed in the northern portion of Building 2.

Approximately 26,000 square feet of resilient vinyl flooring material was observed throughout the first floor and mezzanine levels of Building 2. These consisted primarily of 9" x 9" flooring material located on all floors; however some areas of 12" x 12" flooring material were observed. Heartland encountered numerous boxes of unused resilient flooring materials and other flooring material sample swatches located in a storage area within Building 2. These sample swatches and boxes

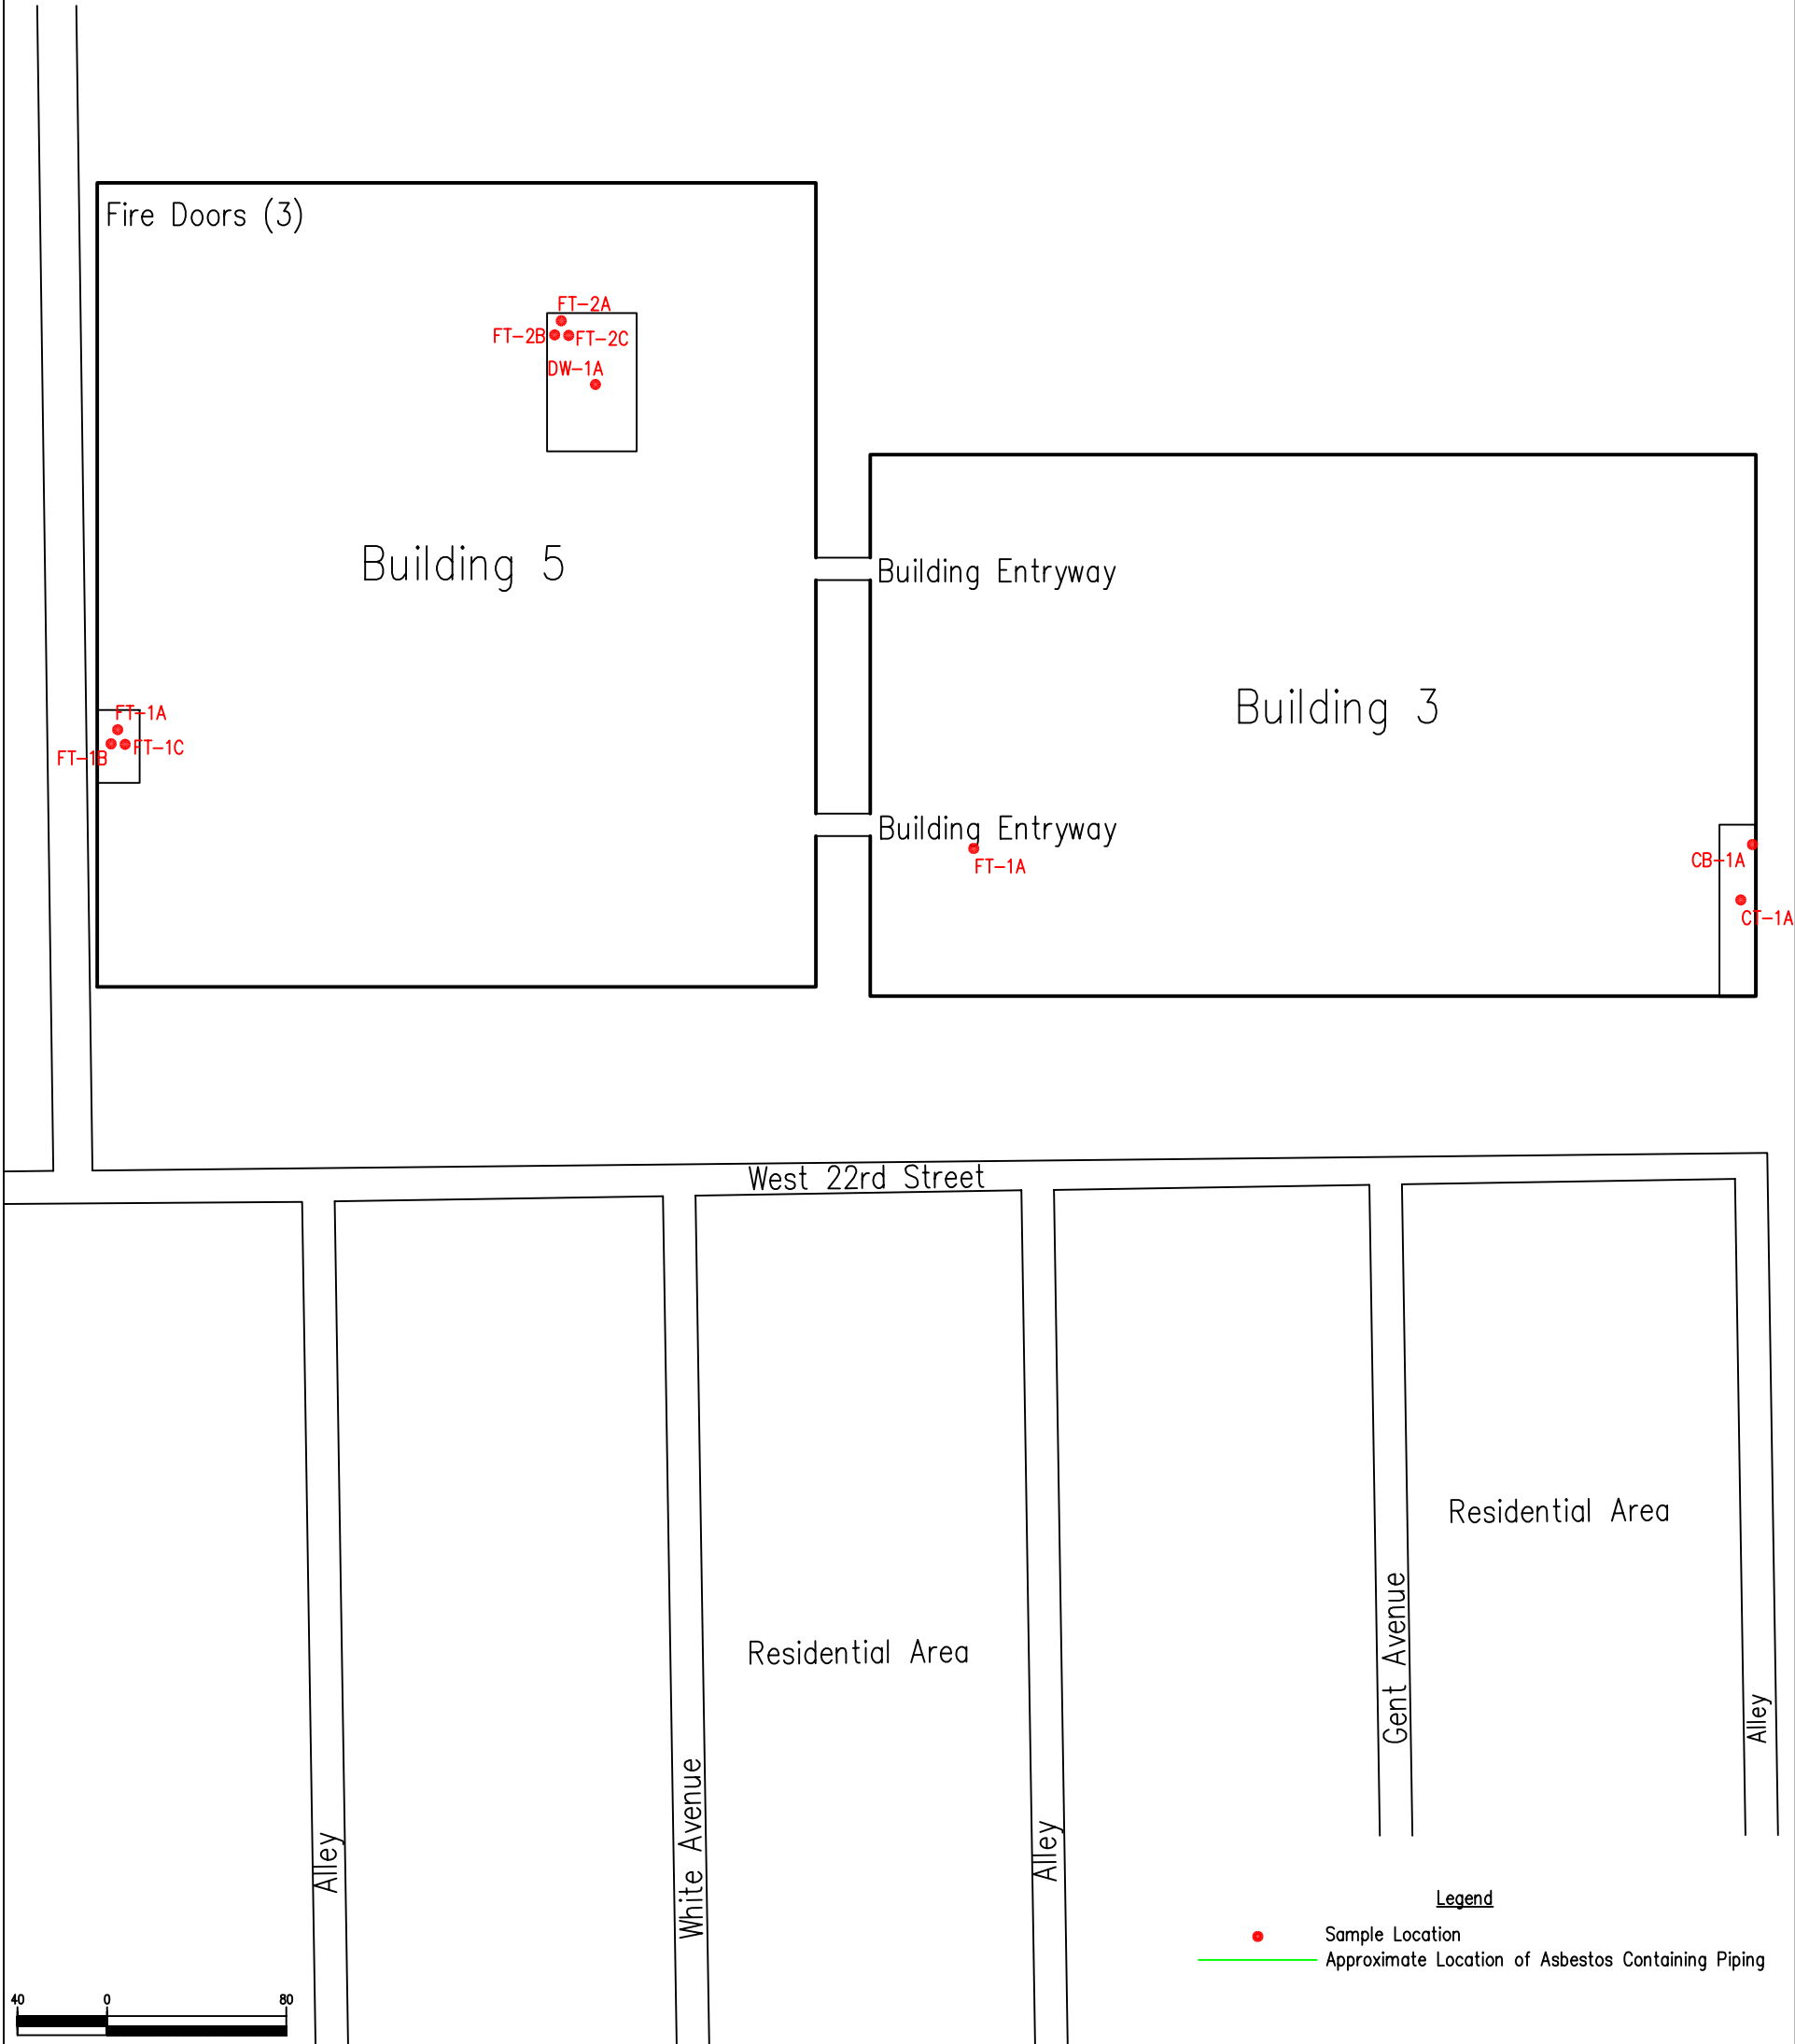
A total of 4 fire doors were observed throughout Building 2. An additional 3 fire doors were observed in the northwestern portion of Building 5.
